# **Initial Stages of Cavitation Damage and Erosion on Copper and Brass Tested in a Rotating Disk Device**

**P. Veerabhadra Rao and B. C. Syamala Rao**  
*Lewis Research Center*  
*Cleveland, Ohio*

**Prepared for the**  
**Cavitation and Polyphase Flow Forum**  
**sponsored by the American Society of Mechanical Engineers**  
**St. Louis, Missouri, June 7-11, 1982**

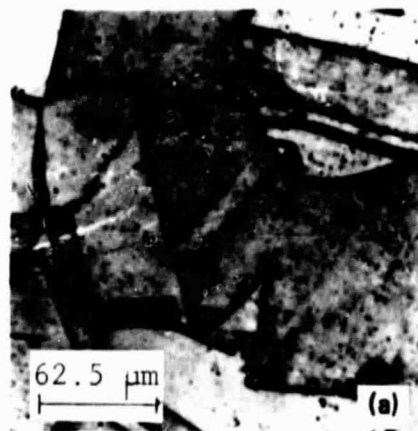
Figure 2. - Photographs of damage progress on copper specimen exposed to cavitation in a rotating disk device at 0.15 MPa (abs) pressure and 37.3 m/s flow velocity. (a) unexposed surface, (b) 0.5 min (damage initiation at weak spots), (c) 1 min, (sliplines and pit formation), (d) 1.5 min, (e) 3 min, (f) 3.5 min.

Figures 2(a) and 3(a) showing the specimen surfaces before test, indicate slight artifacts resulting from sample preparation and etching. During the first 20 to 30 seconds of cavitation attack at a velocity of 37.3 m/sec, damage is seen at the grain boundaries and coarse slip bands develop across the grains on copper (fig. 2(b)). Pits of varying size ( $\sim 5$  to  $25 \mu\text{m}$ ) and shape appear randomly on the surface. The incubation periods (during which no measurable weight losses were observed) for copper and brass are presented in Table 2 for erosion at different velocities.

With increased cavitation attack, the reflectivity of the surface gradually reduced, indicating an increase of pit size and number. The formation of the pits or craters does not appear to be associated with the grain boundaries or other structural/metallurgical features except the etch pits resulting from sample preparation. Using a magnetostriction oscillator, Vyas and Preece (ref. 2) observed similar trends on face centered cubic (fcc) metals like nickel, copper, and aluminum. However, in the present investigation, there seems to be evidence showing that the deformation starts at inclusions and at unfavorably oriented grains and transforms into pits (figs. 2(b) to (d) and (h)). Slip lines are seen around the pit. As the exposure increases from 1 to 3.5 min, the pits gradually broaden across grains as seen from figures 2(d) to (f). The straddling of grain boundaries may be due to differing amounts of plastic deformation within each grain. The central portion of the pits is not damaged initially, indicating a possible type of microjet and/or shockwave

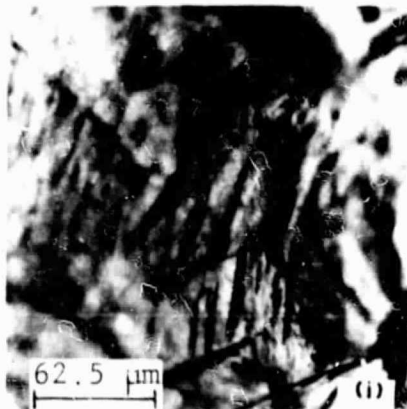
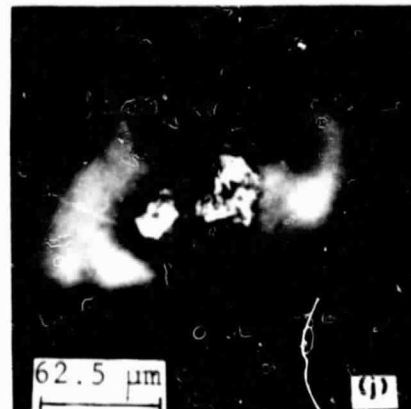
Figure 2. - Concluded. (g) 4 min (damage along grain boundaries and tilting of grains), (h) 4 min (complete grain damage), (i) 5 min (multiple slip), (j) 6 min (pit bottom with plastic flow), (k) 10 min (pits with flow of material), (l) 120 min (macroscopic flow on material surface).

During the initial stages of plastic deformation, there is little indication of the opening up of the grain boundaries to develop into cracks, although the photograph in figure 2(g) is indicative of this possibility. As the exposure increases, the deformed depressions turn into pits, suggesting the development of plastic deformation into fracture due to stress concentration caused by an unfavorable surface configuration. It may be possible that soft regions of lower average yield stress or very small rough regions on the surface could account for local yielding due to impact even though the average impact pressure is low.

The slip lines are initially arrested by grain boundaries, although trans-crystalline damage is observed at severely pitted areas. With further exposure to cavitation, the deformation is primarily by pit formation (fig. 2(h)). The grain structure is completely destroyed and a lot of material flow is observed after 10 min (fig. 2(k)). The particle-removal is believed to occur by ductile tearing from the craters by the end of the incubation period (fig. 2(k)). The macroscopic ductile flow of material is seen in figure 2(l). The "tunnelling effect" observed for both vibratory cavitation and liquid-impingement erosion devices (ref. 12) and on stainless steel using a rotating disk device (ref. 14) is not observed in the present investigation.
